## SERVICE INFORMATION

**ST-009-06**

**SUBJECT:** FC9\* & G\*9\* Furnace Condensate Gaskets Splitting and Leaking

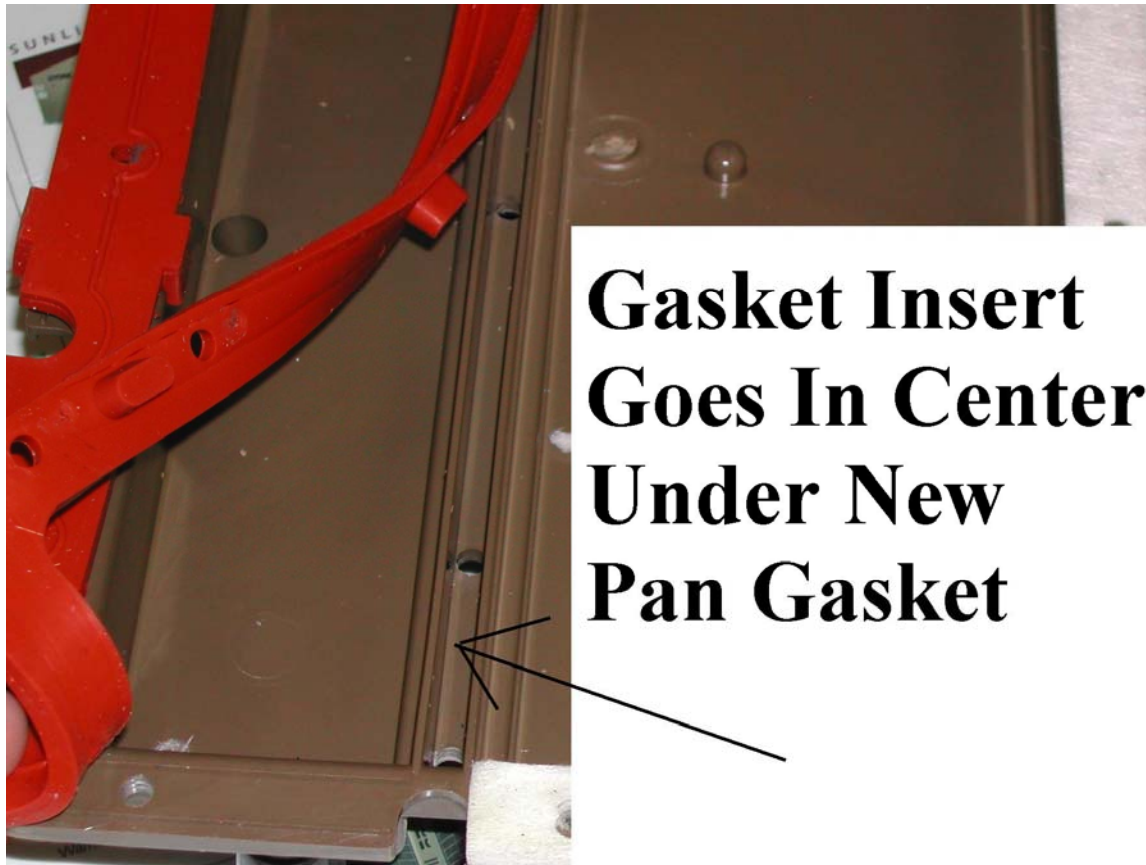
All 40" 90% furnace models currently have a gap in between the two halves of the condensate pan. This gap can allow the pan gasket to split and leak if the screws securing the pan are significantly over-tightened.

To prevent this from occurring an insert/filler was developed constructed of the same Red RTV silicone material as the gasket that fills this gap. Production gaskets have now been changed to add this insert and re-designed gasket.

The insert cannot be ordered separately and will not work with the old style gaskets.  
For replacement, the complete Gasket Kit listed below, needs to be ordered which includes the insert and new pan gasket.
