TECHNICAL SERVICE

YS-049-06 Fix on Fail Only Expires 12/31/07

SUBJECT: 2-5 Ton Champion Gas heat – Electric Cool Units With ECM (Variable Speed) Motors

UNITS: All 2-5 Ton Champion / Affinity Gas Heat – Electric Cool units.

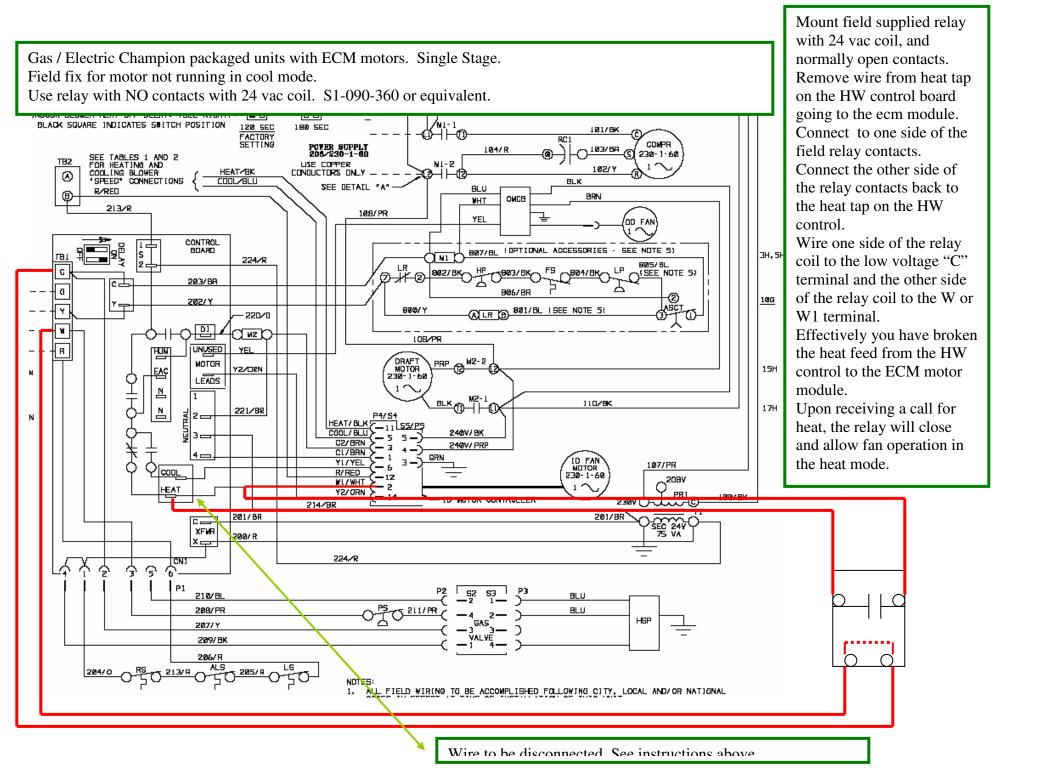
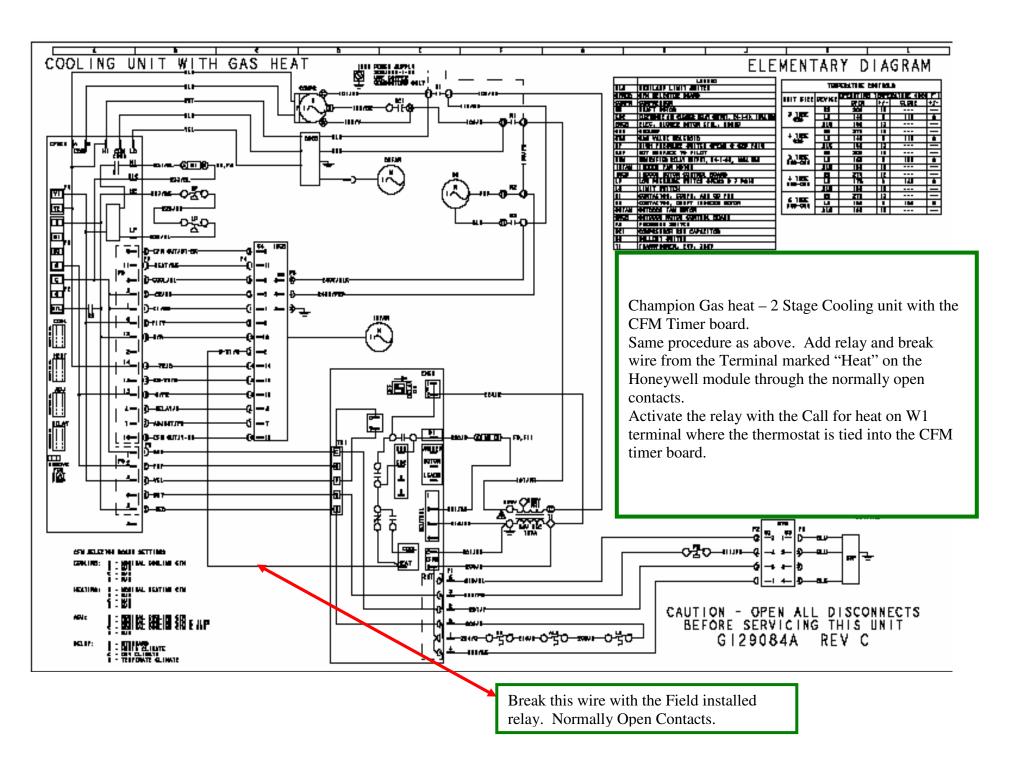
We have received reports of customer complaints that these units could freeze up from time to time. Investigation found that the ECM blower motor used would sometimes not respond to a thermostat requiring call for blower operation. When this happens, the compressor could operate without the blower motor, causing the coil to freeze. The problem reportedly happened at different rates on different applications. Some regularly, some only periodically.

It was found that if the heat signal from the Honeywell control going to the ECM is blocked, the motor does not fail to run.

The fix uses a pilot relay to break the signal from the Honeywell control going to the 16-pin connector on the ECM. (Wiring diagram attached). Suggested relay part number \$1-090-360 or equivalent (24 vac coil, normally open contacts rated 5 amps or greater). This will allow normal operation as the unit was designed.
